“My God It’s Full Of Holes”

1/08/2024

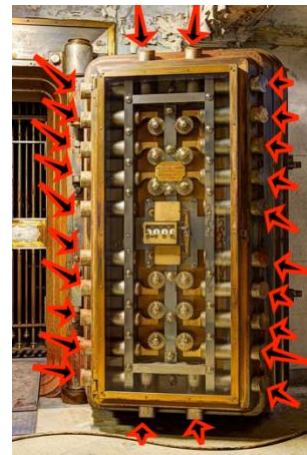
The cargo doors on the McDonnell Douglas DC-10 were outward-opening, in order to facilitate loading. They were kept attached to the fuselage in flight by a number of "fingers" that rotated outward and then gripped the surface of the inner fuselage. The arrangement was very similar to how many bank vault doors are secured – with heavy, stout pins that bear against the inside of the opening.

Except in the DC-10 the pins were never heavy nor stout (it is an airplane, after all).

The baggage handlers were supposed to close and secure the door by rotating a handle on the outside that forced the pins out and locked the door to the fuselage. However, the entire mechanism for doing that was rather under-built and under-designed with the result that a strong baggage handler (aren't they all?) could easily force the lever into position without the pins becoming fully engaged.

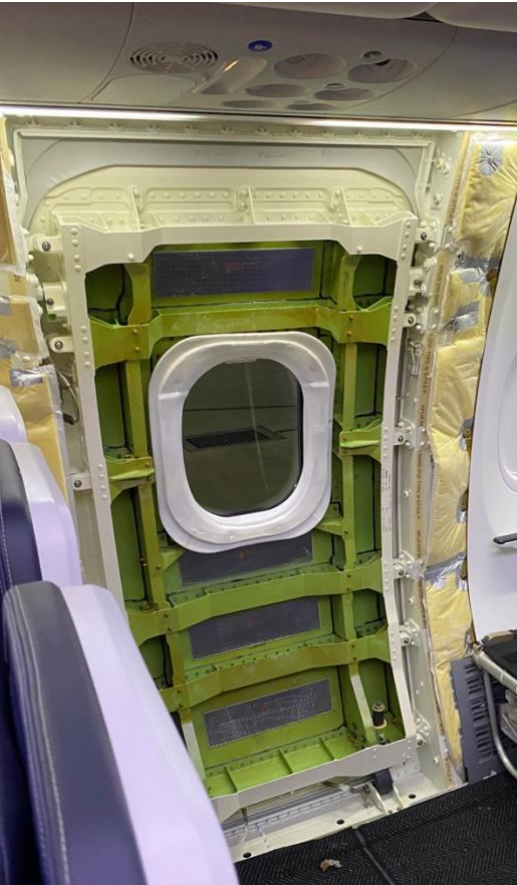
These plugs attach to the fuselage much as a real door would and are even given provisions such as small vestigial hinges which allow the plugs to be easily "opened" if necessary.

Normally the door plugs are held in the fuselage against 12 "stop pads" which are forged aluminum fittings.

For each stop pad attached to the fuselage there is a stop pad on the door plug.

The door plug stop pads sit INSIDE the door frame stop pads.

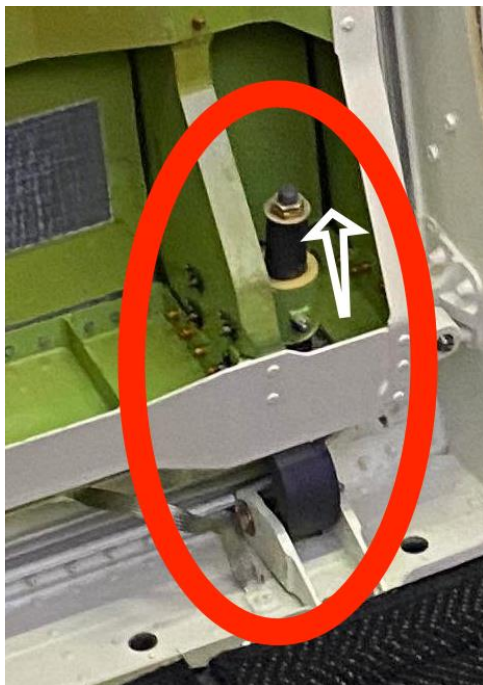
Removing the door means simply moving it UPWARDS a bit (“translating” it in engineering-speak) so that the stop pads clear one another.

This is facilitated by hinges and guide rollers that exist only to make it relatively easy to open and remove the door plug if desired.

The only use of the door guide rollers and the vestigial hinges at the bottom of the door are during maintenance or when the aircraft is being converted to replace the door plugs with actual doors.

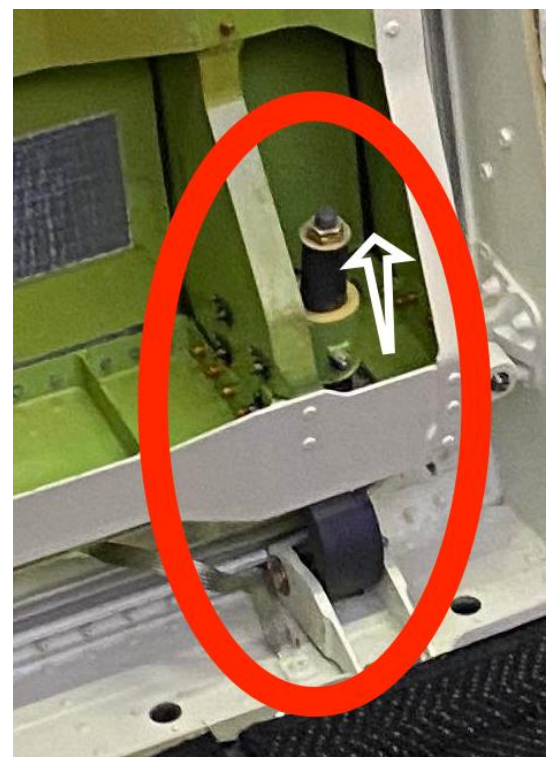
During assembly, the door plug is closed using small hinges at the bottom (FYI a real exit door in this location is hinged at the top, not the bottom, using a big hinge).

And then dropped onto the roller through the notch.

Whereupon the bolt is inserted to secure it.

However just two small bolts to secure the door plug in the upper guide rollers would not be sufficient.

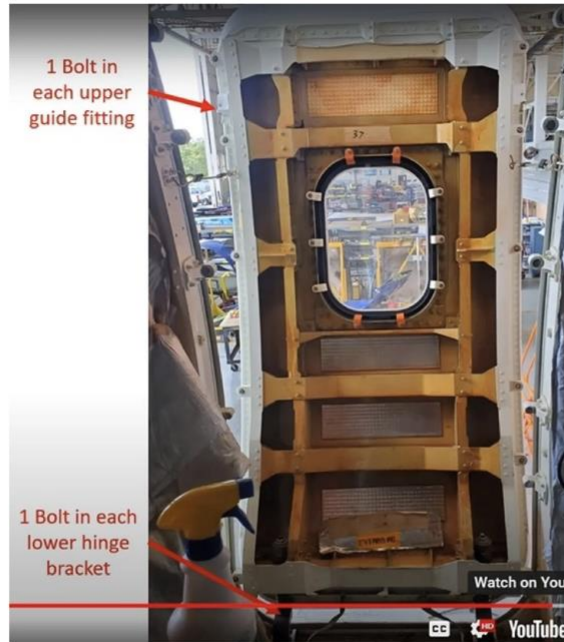
A photo showing the type of door plug fitted to a Boeing MAX 9 aircraft that fell off Alaska Airlines flight 1282. It's secured to the airframe by two bolts at the top and two at the bottom. (Courtesy of Chris Brady at b737.org.uk)

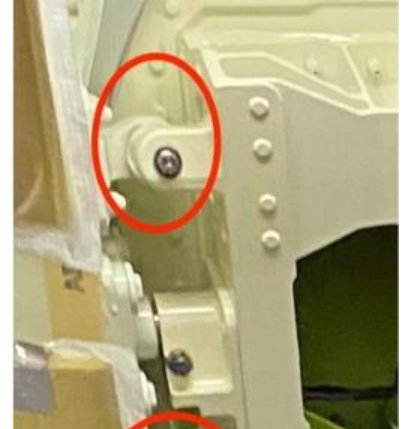
The bolts referenced by Gates do not hold the door plug in.

The bolts are safety devices, used to ensure that the door does not move out of its guide fittings once it is placed in the fuselage hole and when there is no cabin pressurization to hold it firm against the stop plugs.

Think of the guide fittings like the spacers used between bathroom tile that keeps the tile aligned on the wall while the glue that holds it to the wall cures.

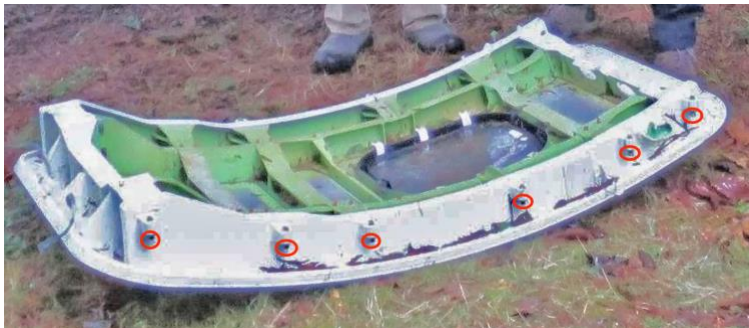
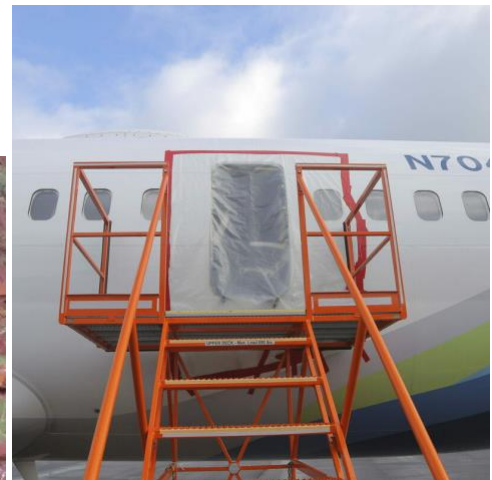
The missing door plug has been found and it is clear that the centering pins are intact and installed although with the picture I have it is very difficult to ascertain their exact condition.

Ordinarily the design of the door plug should make it absolutely impossible for the plug to translate upwards and then out of the airframe if these stops and their centering pins are aligned with and inserted into the female mating holes in the stops in the door frame. Irrespective of whether or not the two bolts retaining the guide slots at the top are installed or not.

This is a current narrative and it is distracting and wrong. If the door plug has its stops, its stops have their centering pins and the centering pins are inserted in the female recepticals in the associated door frame stops, the door cannot move or depart the airframe.

The only way it could is if the door was installed misaligned in the first place. And that that misalignment somehow escaped every quality control and safety check, including an examination OUTSIDE the airplane to see if the door plug was properly aligned with the opening in the fuselage in which it fit
